FAA Integrated Airport System and U.S. DOD:

RUBBLIZING...

Rubblization Process:

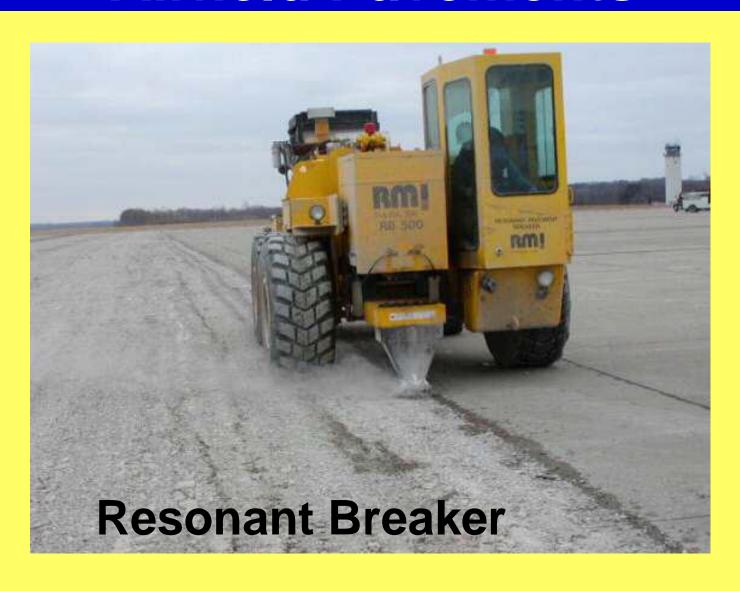
Test pits confirm:

- Complete slab destruction
- Complete de-bonding of steel (if present) in outside panels
- Particle size distribution
 - Max size < 30 cm (12in)

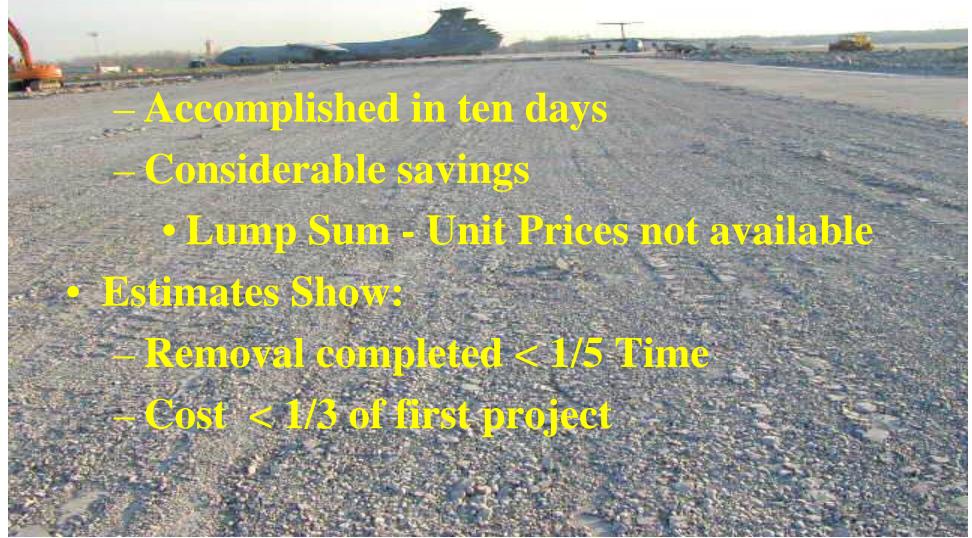
Rubblization at WPAFB:

Wright-Patterson AFB, Ohio

Project was designed for removal and replacement

- Inspection of the rubblized material prior to removal:
 - •Rubblized pcc a high quality base material
 - Rolling would prep and ready for an overlay
- Rubblization provided information on:
 - Benefits for fast, economical removal
 - Proof that process viable on thick concrete

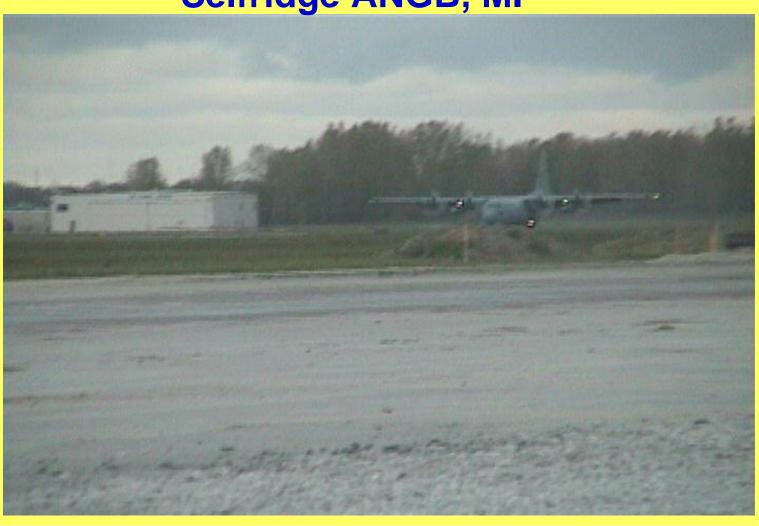
Selfridge ANGB, MI

Selfridge ANGB, Michigan

- Five military branches of service
- Main heavy load R/W was 9,000-foot with 22 inches of NRCP
- To minimize disruption to overall base operations:
 - A taxiway used as temporary runway
 - Old pavement was rubblized and left in place as new base
- Runway was turned over to the contractor on April 1st, 2002
 - Back in service on September 15th
 - Faced \$15,000/day liquidated damages

- May, 2002, 95,000 SY concrete runway was rubblized in sixteen (16) days.
- The rubblizing specification required that a minimum of 75% of the broken concrete particles not exceed
 - 3 inches at the surface
 - 9 inches in top half of the pavement
 - 15 inches in bottom half of the pavement

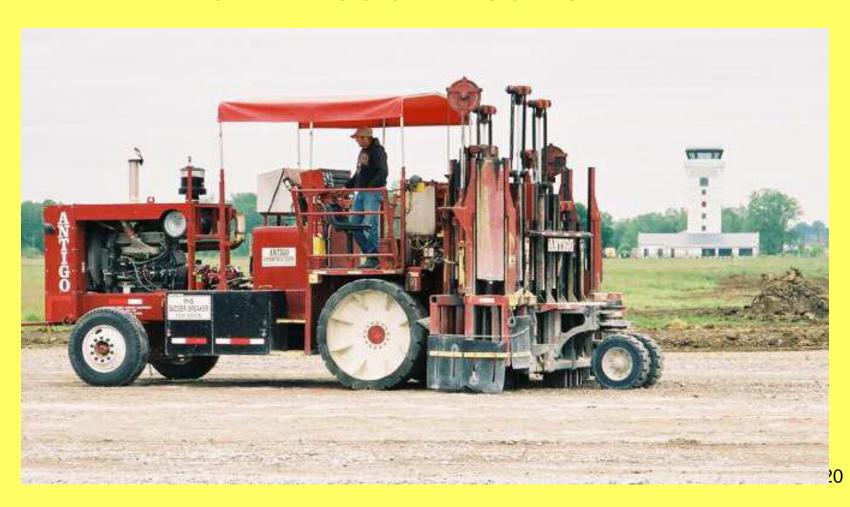
Multi-Head Breaker

Extremely thick PCCP > 50cm (20inches)

- May have been built in two separate layers or lifts.
- Shear plane absorbs some of the breaking force
- May need to be pre-broken

Both Machines are effective but operate in completely different modes

- Resonant breaker: high frequency, low amplitude process
 - Breaking unit produces 3/4 inch amplitude impacts
 - Frequency of 44 per second (hertz)
 - Through a massive steel beam with a foot attached
- Multiple-head breaker: low frequency, high amplitude process
 - Eight pairs of 1200 lbs hammers raised to a height of 0-60 inches
 - Impact the pavement between 30-35 (.5 hertz) times per minute
- Research underway to determine if difference between the two process and their effect on:
 - the underlying subgrade integrity
 - layer permeability
 - effective modulus of the rubblized material

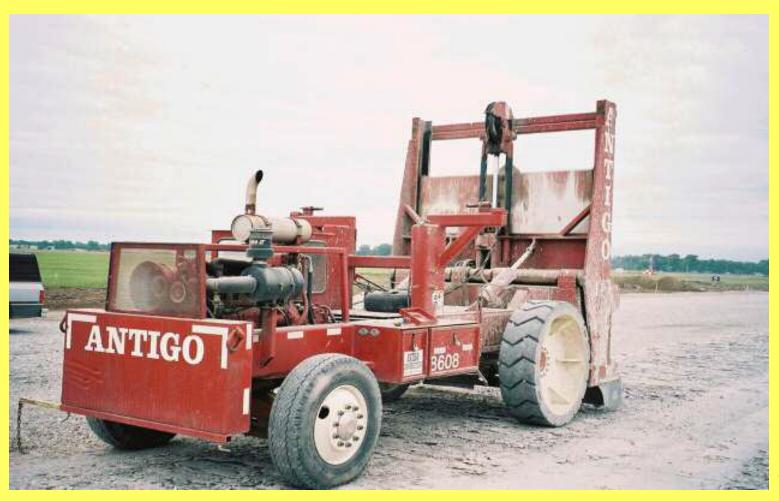
Guillotine Breaker

Drop or guillotine style hammer may be used

- Insure adequate slab destruction through out
- Specification compliance
- Expedite the rubblization process

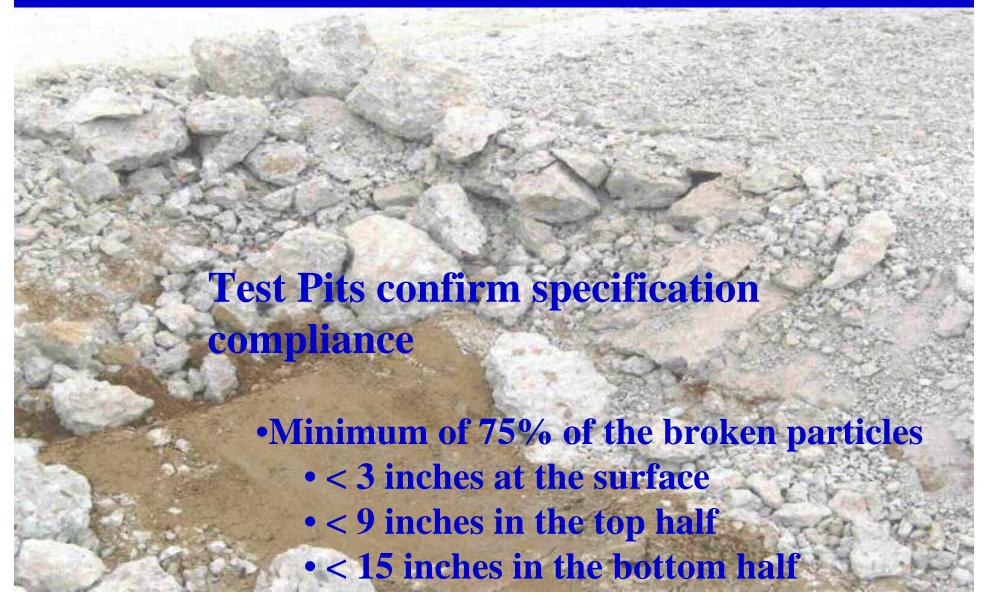
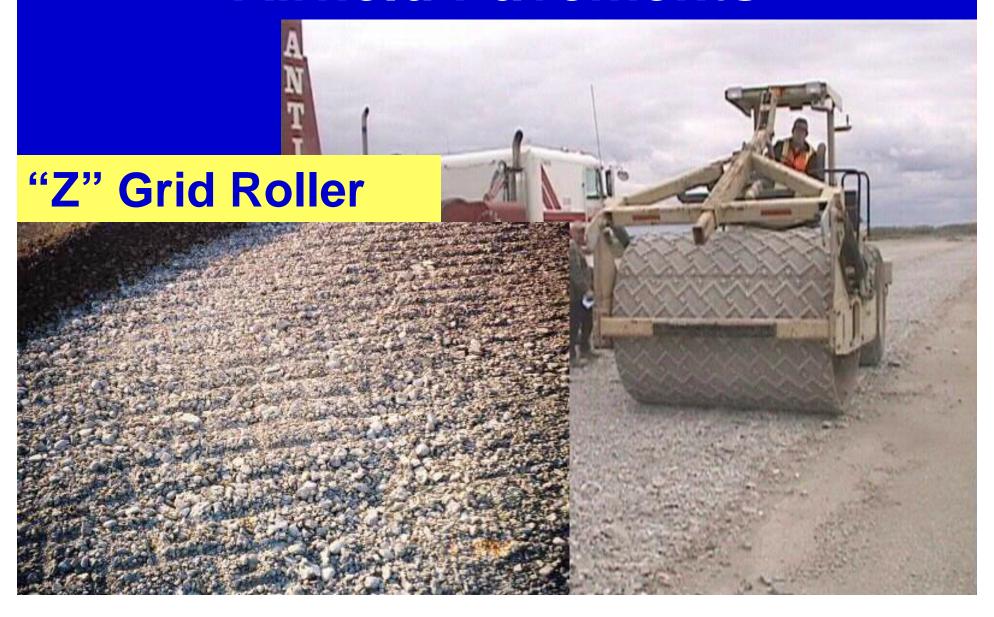
After rubblizing with Multiple-Head Breaker

- Prepare surface for HMA overlay
- Roll with two passes of a special "Z" grid roller
 - weighing approximately 23,000 kg (25 tons)
 - to provide a uniform surface
 - to reduce the size of the surface pieces
- Followed by a 22,680kg (25ton) pneumatic-tired roller for final densification and alignment of fractured pieces

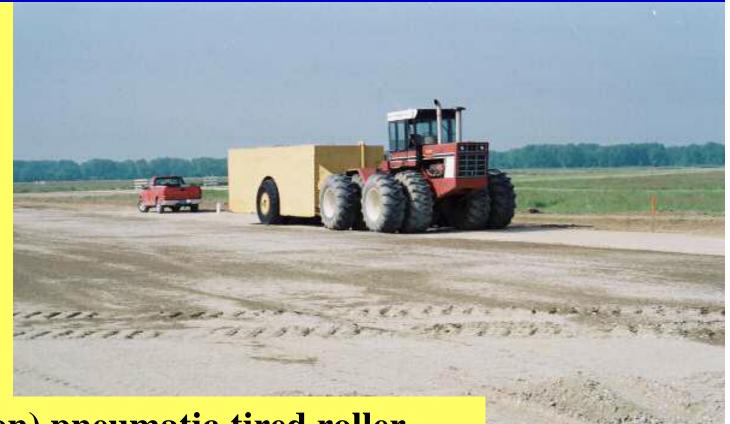
22,680kg (25ton) pneumatic-tired roller

- •final densification
- alignment of fractured pieces
